Society for Industrial Archeology · New England Chapters

VOLUME 10 NUMBER 1 1990

The Restoration of the Cornish-Windsor
Bridge

The Moseley Iron Arch Bridge

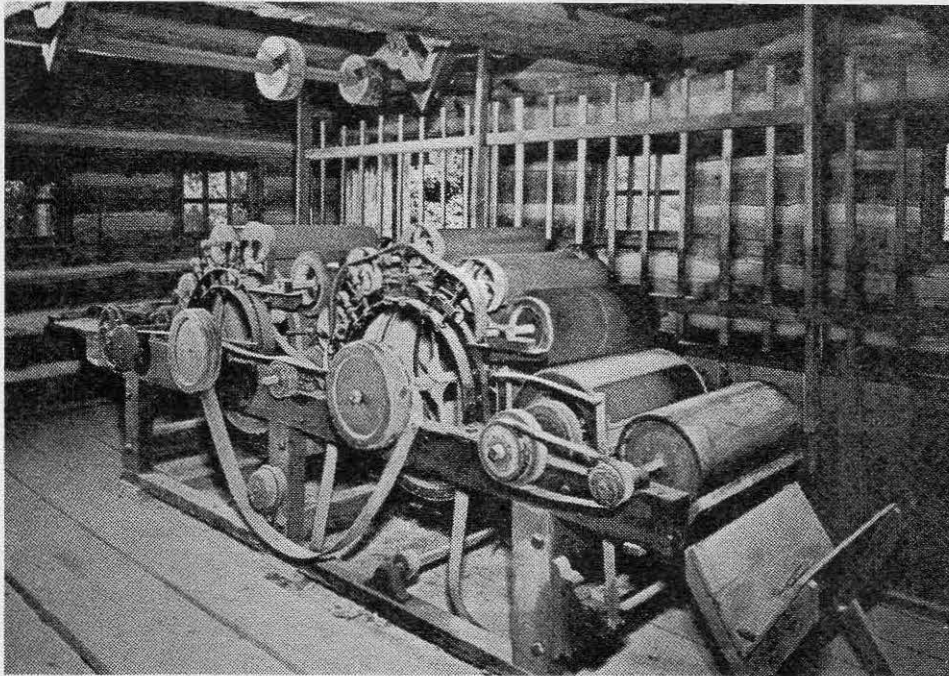
The New Salem (Ill.) State Park carding machine as it appeared prior to restoration by Thomas Rockwell of North Andover (from post card printed by Dexter Press).

been made about 1830 to 1840 by a carding company in Worcester, Massachusetts; it had been severely damaged sometime; it was in poor condition; all parts would have to be repaired and welded; the rust would have to be removed; the final wooden roll would have to be fluted; and there were only a few small parts missing.

The striking feature of the card was that it was in two main sections, and these two sections did not match each other. One theory was that at some time the card had been smashed, and the parts were replaced from another carding machine. The other idea was that perhaps the card had originally been a one cylinder machine, and it had been enlarged to make it a two cylinder machine. The latter theory seems to be the more likely. The two main rolls were not the same construction as they would have been if the card had been originally manufactured as a unit. Some of the pulleys were made of wood and some of iron.

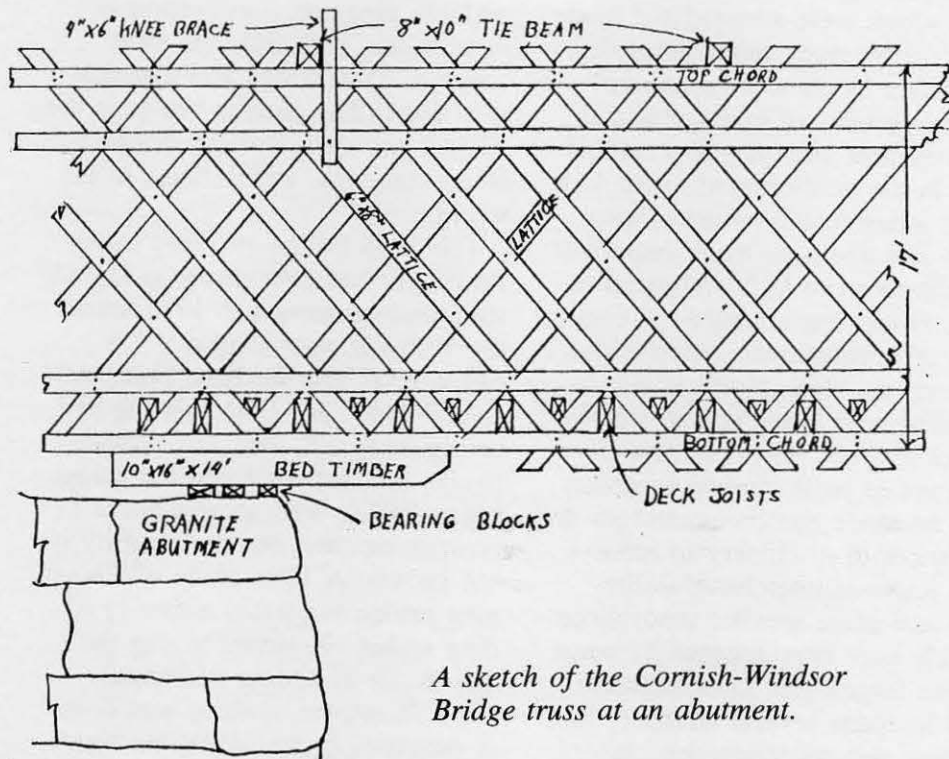
A sketch of the Cornish-Windsor Bridge truss at an abutment.

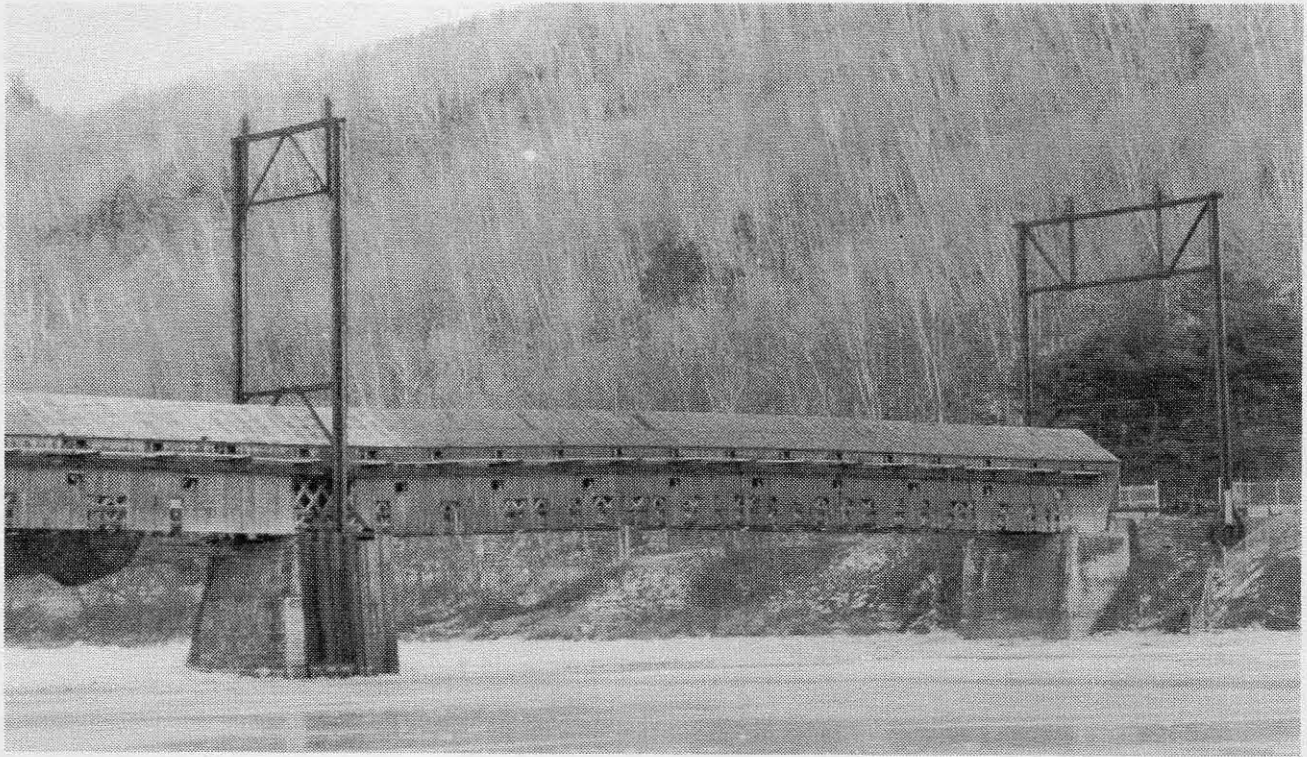
The eastern span of the Cornish-Windsor bridge with its suspension system rigged on temporary towers forcing a positive camber. The suspension wires connected to the needle beams supporting the upper chords cannot be seen in this photo.

steel needle beams between the two upper chords, and attached the needles to the towers at 24 points by means of threaded steel rods. Thus, Cornish-Windsor was temporarily turned into a two-span suspension bridge. A large nut could be driven up the rods by means of a hydraulic wrench, pulling with it a frame attached to the needle beams. By this means, and by dint of great labor over two weeks time, we were able to drag the bridge up into 24 inches of positive camber. We would repair the bridge with this much camber in it, hoping that, when released from the suspension system a year later, it would retain at least some of it.

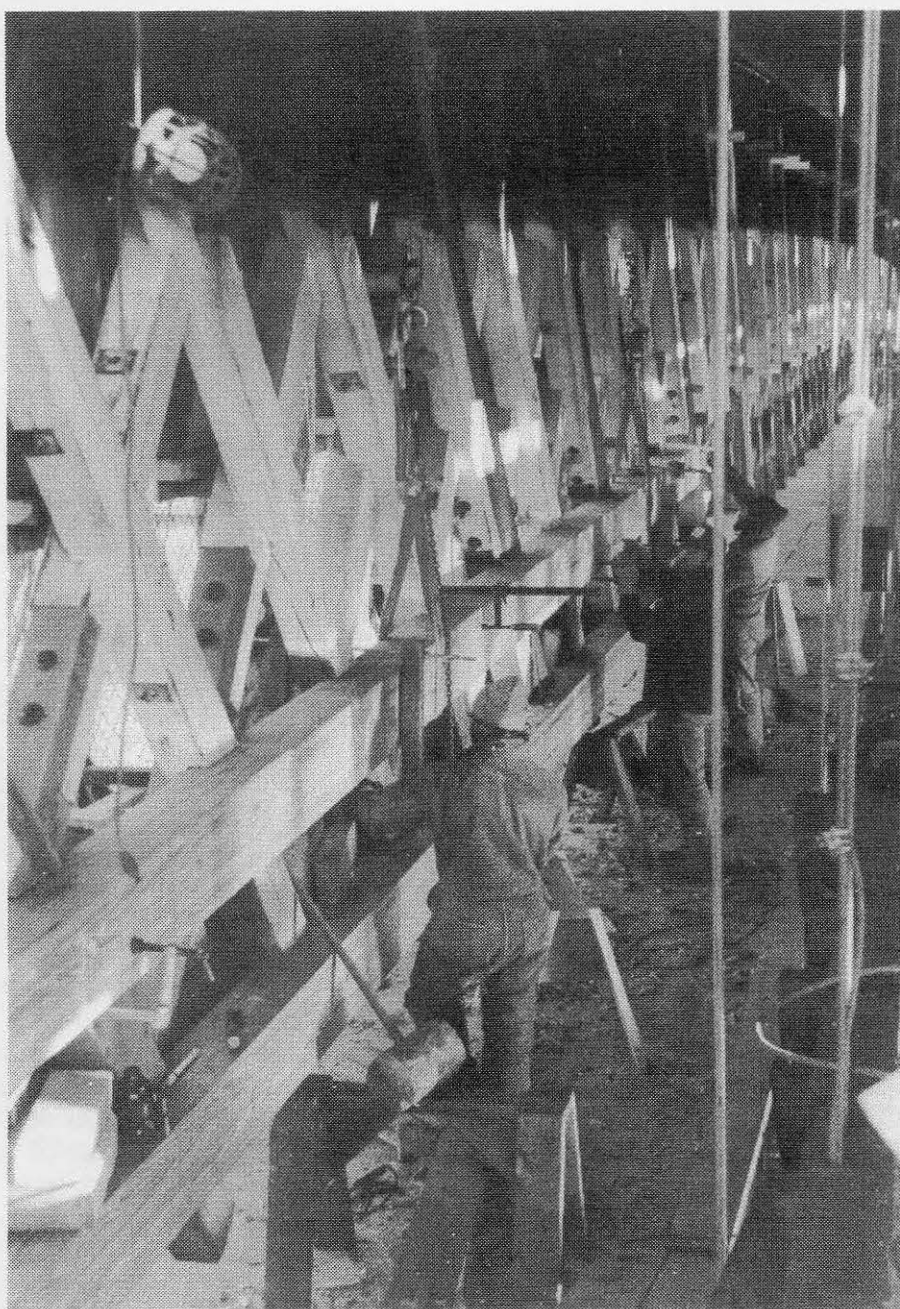
Installing the gluelams on the Town lattice.

The upper chords were replaced by 88-foot gluelams, but only over the central pier. The highest tension loadings in the bridge occur there, and the old chord system was opening as much as 1 inch per joint, cracking, and denting its shear blocks deeply into the end grain of the spruce. The remaining 3400 linear feet of the upper chords were repaired where necessary (19 points) with 32-foot pieces of Douglas fir, using ash, maple and oak shear blocks and bolts, and can be truly called a "restoration" in terms of technique.

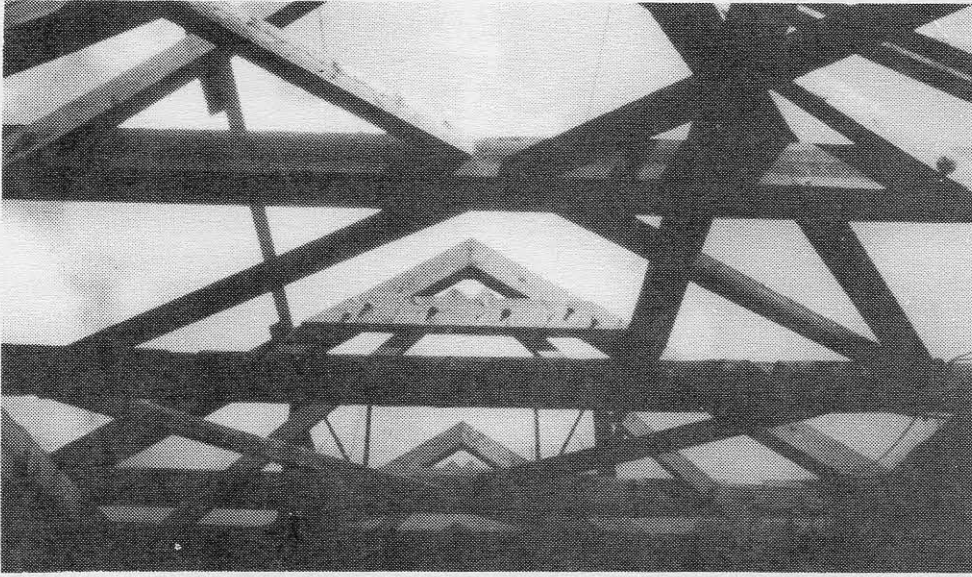
The overhead lateral bracing system strengthened by doubling the number of tie beams. The braces were mortised from the end of one to the middle of the next.

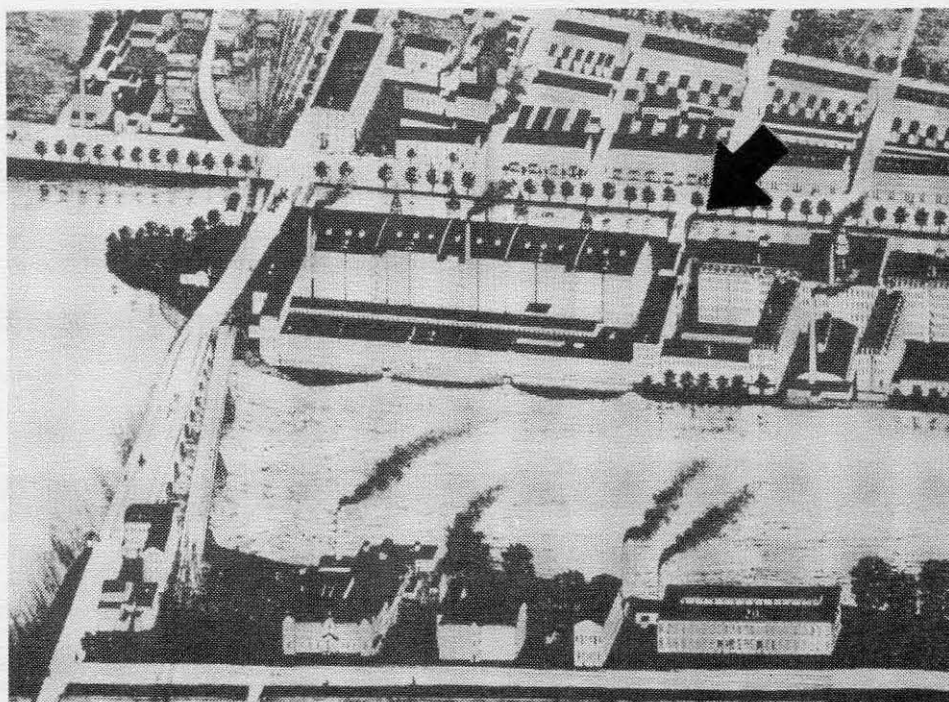
Fig. 1. *The Great Stone Dam, North and South Canal, Moseley Iron Arch Bridge.*

The Moseley iron arch bridge built across the North Canal in Lawrence, Massachusetts, in 1864 is shown in Figure 1 by a large arrow. The bridge is the earliest surviving bridge constructed to provide access to the mills for workers who were to live in the nearby company housing as well as for deliveries and shipments by horse-drawn wagons. It is also the oldest extant iron bridge in the Commonwealth of Massachusetts and one of the oldest bridges in the United States built entirely of wrought iron. It is one of only three bridges built by Moseley still in existence. One of these, located in Claremont, N.H., is a bowstring but with the web members in a diagonal pattern. It was a foot bridge across the Sugar River and is in danger of imminent collapse. The other Moseley is reported to be in Eppingham County, Illinois.

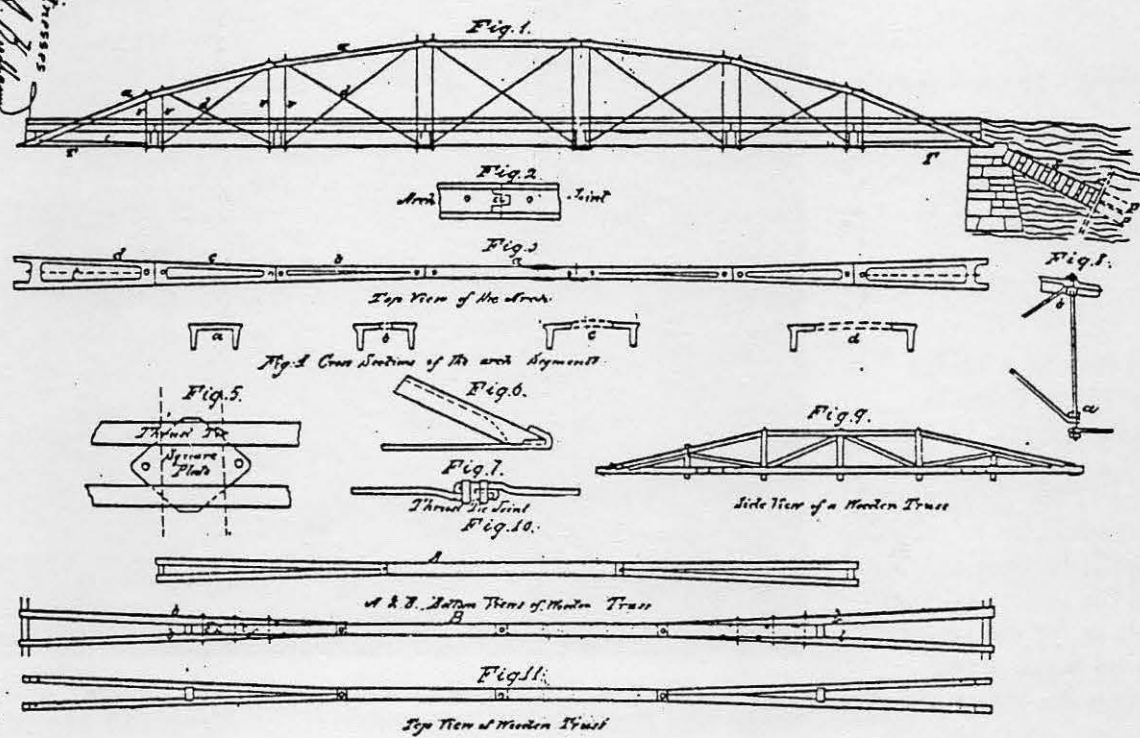
*S. Whipple -
Bridge.*

Fig. 2. Whipple Bridge patent drawing.

Thomas W. H. Moseley was issued patent no. 16572 on February 3, 1857 on a "truss bridge." This bridge was fabricated entirely of wrought iron plate, bar and strap stock at a time when Squire Whipple, the premier iron bridge builder of the time, was constructing bowstring trusses, patented in 1841, made of cast and wrought iron. Whipple's and Moseley's patent drawings are shown as Figures 2 and 3. Both are tied arches with

the string (lower chord) being in tension and made of wrought iron. Whipple's top chord, however, consists of cast iron segments, while Moseley's is made up of continuous riveted wrought iron plates arranged in a triangular pattern. The main visual difference between the two, however, is in the diagonals. Whipple makes use of what, at the time, were called "braces" and "counter-braces", while Moseley's diagonal pattern defies description, being a series of straps on something approaching a radial pattern. We all know (well, most of us know) that Whipple has been called "The Father of Iron Bridges" and that he wrote the first book anywhere to describe methods for analyzing a truss. But who was Thomas Moseley, and what was the significance of his bridge?

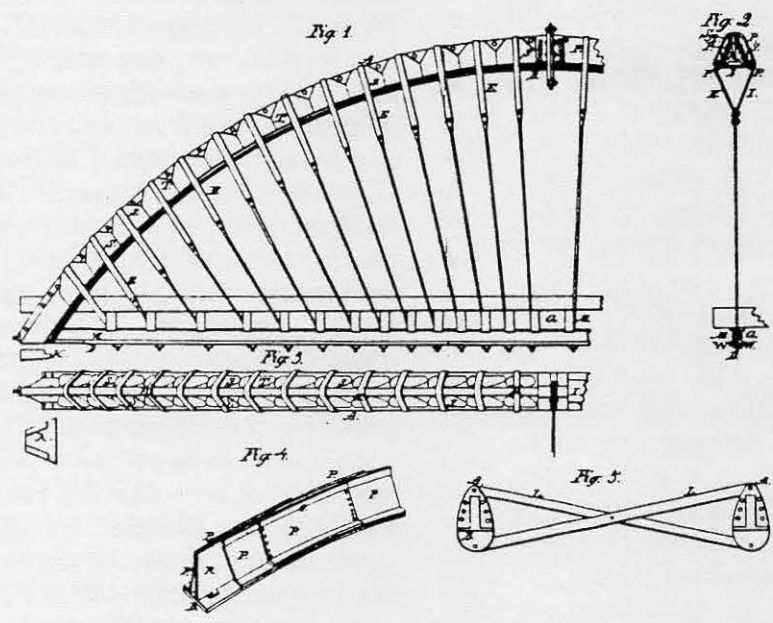
No. 4,374

Fig. 3. Moseley Bridge patent drawing.

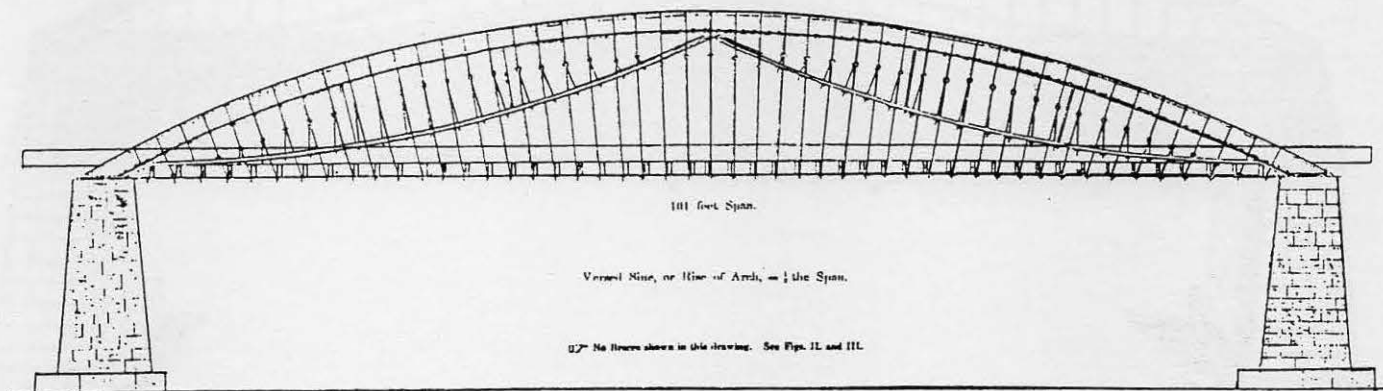
FIG. 1.—SIDE ELEVATION.

Scale 1 inch = 1 foot.

Moseley asserts that under a strain exerted in any direction upon this compound arch there is less risk of buckling of either of the plates than in any other structure for the purpose. In order to prevent all risk, however, of buckling, loose pieces or saddles s-s are used, resting upon the plates B, and also bearing against the plates P, supporting each other by their edges, which come into contact as seen at T. Over the upper edges of the saddles, and receiving part pressure thereof, are the stirrups E of the suspension rods F. The floor of the bridge rests upon the chord M, sup-

ported by the suspension plate D. This plate is not fastened to the lower chord M, and the effect of which is that every load draws upon the whole arch in consequence of the sliding movement of the suspension plate under the chord."

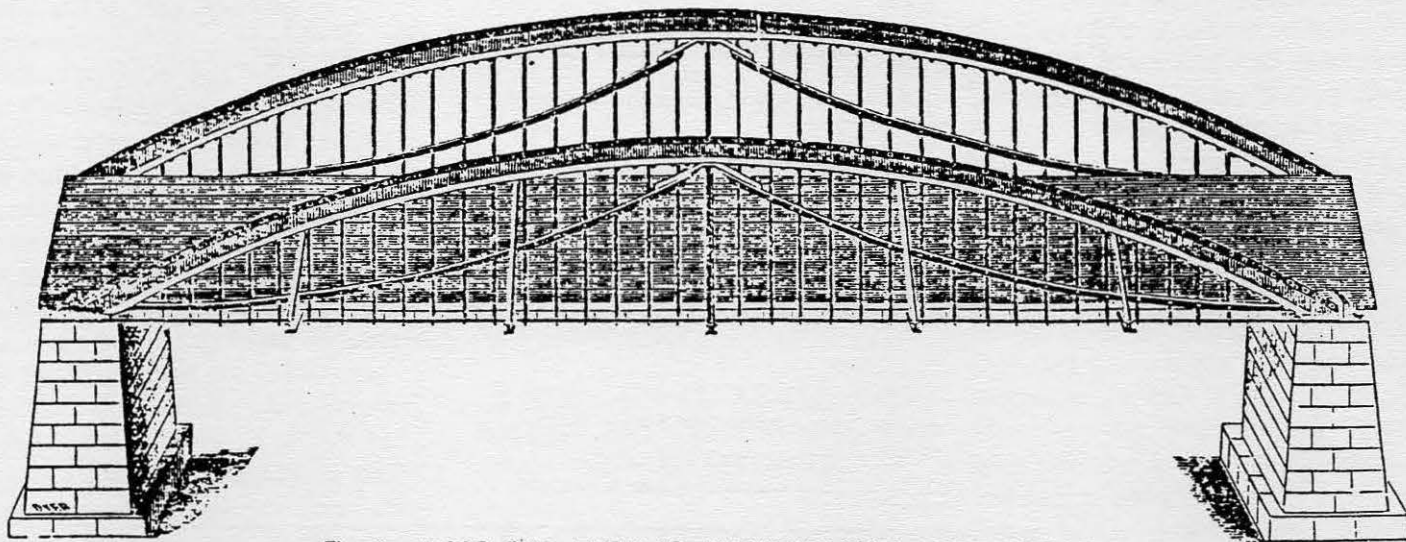
Fig. I. MOSELEY'S TUBULAR WROUGHT-IRON ARCH BRIDGE.

PERSPECTIVE VIEW OF HIGHWAY BRIDGE.

We next see his revised arch in his 1863 prospectus⁴. This version is shown as Figure 4. He stated in his article that "In 1859, a radical improvement was made in the bridge, greatly increasing its strength and stiffness." This improvement was the addition of the counterarches which are evident as well as an additional short piece of iron running from the bottom of the loop over the top chord to the counterarch. What this was for is not known, either now or probably then. The saddles, s-s, are gone, and the stirrups are now round bar stock. His suspension straps are now made of 5/8" wrought iron bar stock which were hooked by a loop to the saddles. He built several of these new improved bridges in Ohio and in Boston, Massachusetts, in the late 1850s and early 1860s.

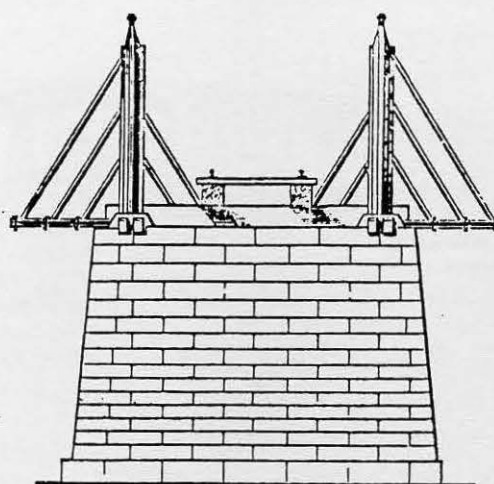
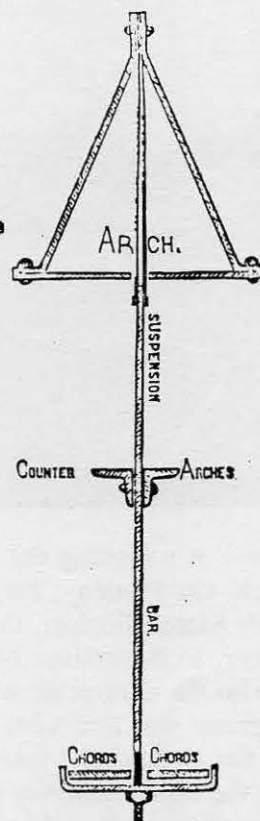
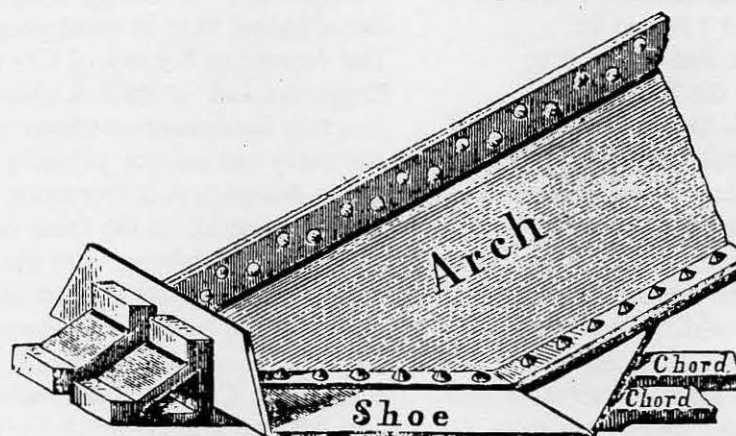
Fig. III. Section of Railroad Bridge.

Fig. IV.
Section of Arch, Chords, &c.

Fig. V. Part of Arch, with Shoe and Chords.

Fig. 6. Moseley detail drawings,
[Figures III, IV, & V].

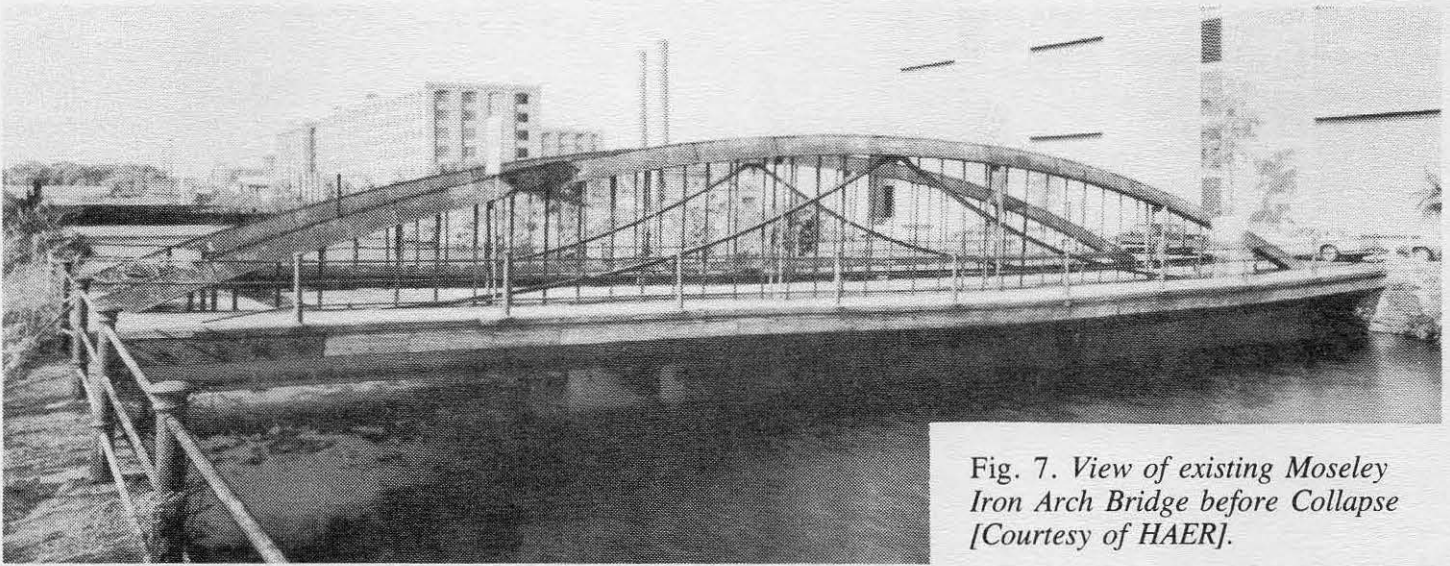
Fig. 7. View of existing Moseley Iron Arch Bridge before Collapse [Courtesy of HAER].

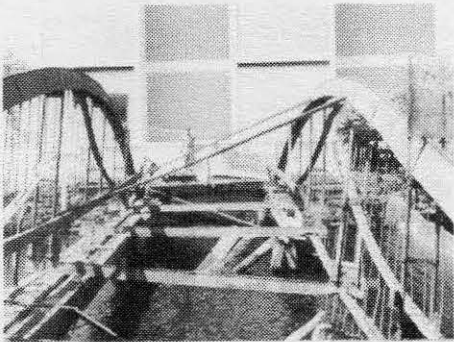
Fig. 8. View showing right arch with deck removed and temporary lateral support in place.

In the summer of 1989 the bridge's wooden under structure partially collapsed and caused the eastern arch to buckle at about the third point (Figure 8). The owner, Atlantic Enterprises, was instructed by the City Engineer to either repair the structure or replace it with a new bridge. Atlantic Enterprises, being the landlord to many companies on the Island, was under lease obligations to provide pedestrian access across the canal and had decided to replace the bridge. What follows may be hard to believe but is absolutely true. On Sunday July 9, 1989, I said to my wife "let's go over to Lawrence to see how the Moseley was doing". When we got there, I discovered the collapse and that someone was
