# Society for Industrial Archeology · New England Chapters

### **VOLUME 37**

## NUMBER 1

# **The First Winchester Brass Mill**

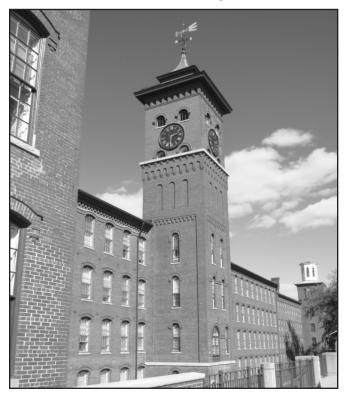
Much discussion about the generators

From there we drove the 3-mile canal distance to the Nashua Manufacturing Company's brick mill building with its identifiable clock towers. Down in the basement we examined the old power generating turbines. They were state-of- the-art in their day but are now replaced by the newer hydro-station back at the falls, which serves the whole area. Up in a clock-tower we saw the actual workings of one of the clocks. It was built in 1901 by E. Howard and Company.

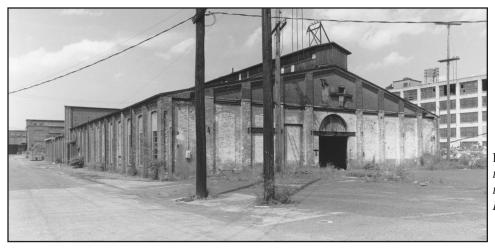
Figure 1. 1992 View Northeast of the Winchester Brass Mill after the Adjoining Cartridge Shop was Razed. Photo by William Sacco

The mill erected by Winchester in 1883 was a one-story 130-by-101-foot structure facing Newhall Street near the corner of Argyle Street in New Haven. The company designated it F5, and added a 90-by-101-foot extension, F6, in 1886. With a few minor additions this structure accommodated the melting and casting shop, rolling mills, and annealing furnaces needed to make brass sheet from primary metals (Figures 1-2).
