## *Society for Industrial Archeology · New England Chapters*

**VOLUME 40      NUMBER 2      2019**

## Flock Process Dam No. 1 on the Norwalk River

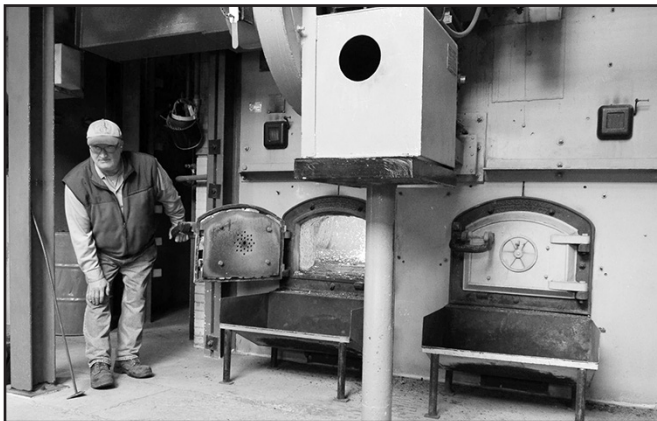
*Cersosimo Lumber Co. drying kilns.*

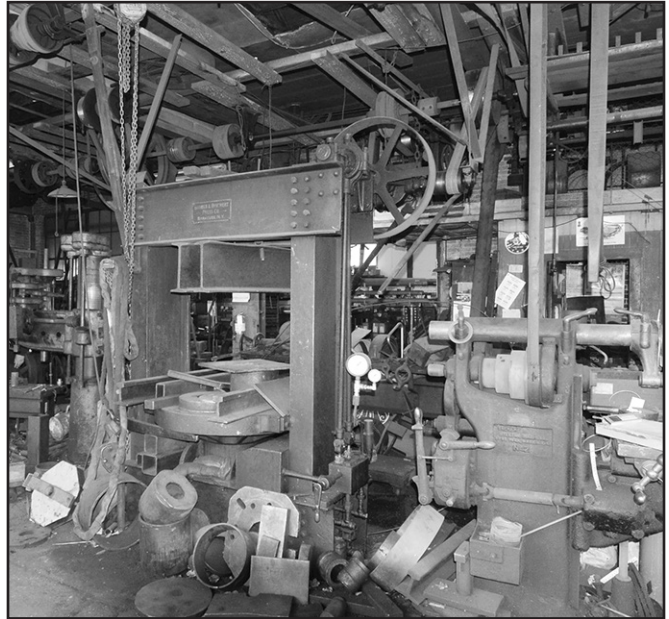
*Lester Dunklee's Machine Shop press.*

**Lester Dunklee's Machine Shop** is a real gem. It has all very old equipment for making or fixing almost anything. People and companies come from three states for his expertise. His latest machine is c.1950 and most are older. Lester can machine, press (to bend or fit) and weld to make new things or fix old things of any metal. No modern computer-controlled machinery can do what he can from his lifetime of knowledge and experience. Tight tolerances aren't needed for the type of work he does; knowledge, experience and skill are. We marveled at the old equipment that we never thought existed and at Lester's Yankee ingenuity. See a video of Lester's shop here: <https://www.brattleborotv.org/it-happens-brattleboro/lester-dunklees-machine-shop>

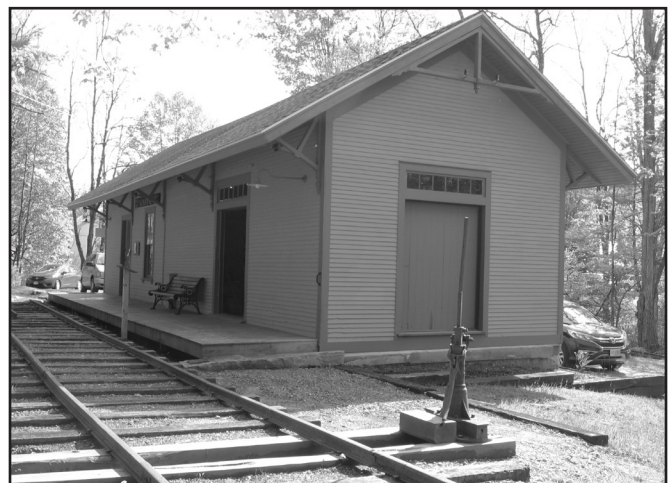
*West River Railroad Station: this unique station contains an enclosed water tank.*

**West River Railroad Museum & Newfane Railroad Station:** Constructed in the 1880s and used through WWII, this unique station contains an enclosed water tower. When the steam engine was replaced by diesel during the 1950s, water tanks became obsolete and most were torn down. This water tank house, however, has miraculously survived these 135 years.

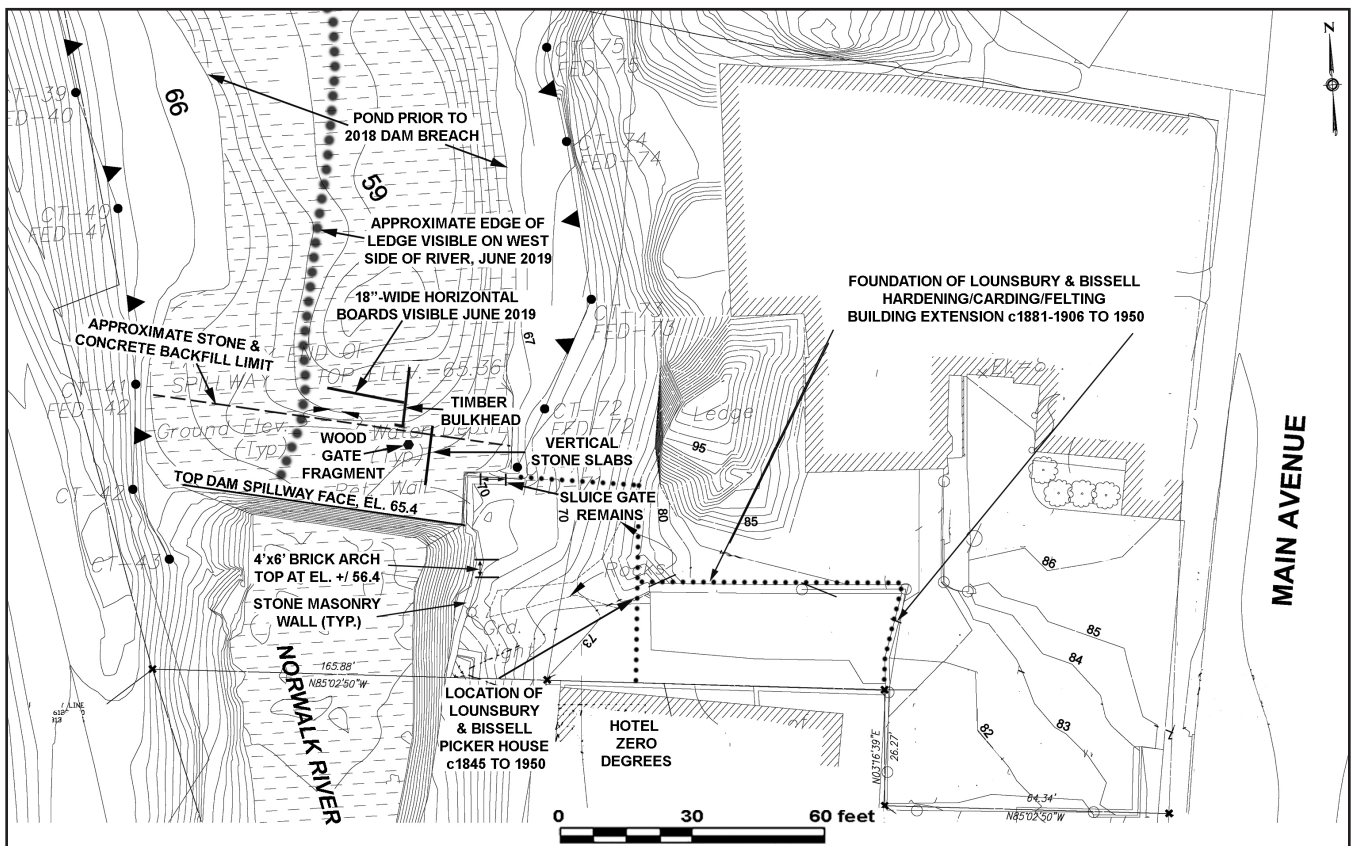
Figure 2 (Below). *Plan of historic industrial features at and near Flock Process Dam. Vertical datum: NAVD 88, horizontal datum: NAD 83 Connecticut State Plane Coordinate System.*

58 square miles. Approximately half the drainage area is upstream of the Flock Process Dam, the most downstream surviving impoundment on the river, located approximately 4 miles upstream of Long Island Sound and 900 feet south of the Merritt Parkway in a rocky upland section of the basin with gneiss and schist bedrock exposed on both sides of the channel. The river here emerged as a late-glacial channel through meltwater stream deposits of sand, gravel, and silt. Original Holocene terrain at the dam vicinity has been obscured by industrial and post-industrial development, but present topography suggests that the channel above the dam once flowed through a low floodplain 100-350 feet wide between steep bedrock-controlled slopes. The bedrock made the site amenable to ponding by an impoundment built where the slopes are approximately 80 feet apart. Immediately upstream of the dam, the slopes are 90-100 feet apart with a steep slope along the west bank and a narrow floodplain on the east side (Figures 1, 2).

Prior to removal in 2018, the Flock Process Dam, formerly known as Winnipauk Dam, was a gravity structure built on bedrock with an approximately 70-foot-long, 15-to-18-foot-high vertical-faced mortared-rubble spillway, capped with concrete and backed by earth and rubble extending approximately 18 feet upstream. The spillway cap had probable wood planking at the upstream and downstream edges (c.1981) and had an upper elevation of approximately 65.4 feet above mean sea level. The width and foundations of the spillway masonry were undocumented. The dam created a head for waterpower of approximately 12 feet. The west side of the spillway was tied to bedrock in an undocumented manner. The east end of the spillway was built against an unmortared masonry foundation for part of a former mill complex noted below, with an unmortared masonry training wall extending approximately 140 feet downstream of the dam below the building foundations. The walls at the east abutment extend 12 feet upstream of the spillway face and surround a deteriorating outlet structure of stone, concrete, and brick with an inoperable 5.5-foot-square wooden sluice gate and bevel-gear steel operator at the inlet and a 4-by-6-foot brick arch at the outlet. There was also a poorly-documented 2-foot-square opening in the spillway face which may have served for limited pond drawdown. Other than the training wall, and the fragmentary building walls at the east abutment, most remains of the mill complex have been removed, with much of the site presently occupied by the Hotel Zero Degrees immediately south of project limits. The Project area extended east of the dam approximately 160 feet to Main Avenue and included part of another mill foundation consisting of an approximately 57-by-17-foot concrete floor bordered to the east and north by 8-foot-high unmortared rubble walls. The latter remains were part of a felting, hardening, and/or carding building noted below. A bituminous parking lot extends between this partial foundation and Main Avenue. On the west bank, the dam site is bordered by the former Danbury and Norwalk Railroad (now part of Metro North), which crosses to the east side of the river approximately 130 feet downstream of the dam, on a 140-foot-long plate-girder bridge with abutments and a central pier of rubble masonry (Figures 2, 3, 9).

As exposed by 2019 high water, the lower portion of the spillway's east end consisted of large flat stone slabs approximately 8 feet long and indicating at least one step in the upstream face (Figure 2).

2. Spillway backfill consisted primarily of large cobbles, sand, and gravel, with a 4-inch-thick concrete cap reinforced with 1/8-inch-diameter wire. Larger boulders were used at the west side of the backfill against bedrock surfaces. The backfill extended upstream approximately 18 feet from the spillway, sloping gradually to an approximate elevation of 63 or  $\pm 2.4$  feet below the spillway cap. As discussed below, the configuration of backfill immediately upstream of the sluice gate was not clear and may have been modified to allow for gate operation (Figures 2, 3).

upstream and slightly below the edge of spillway backfill (Figures 2, 6). By June 2019, high water had removed or knocked down all the vertical boards and removed rubble on top of the bulkhead to reveal large 9-inch-high horizontal timbers resting on timber bracing and possible rubble supports. The timbers were approximately 12 feet long, with a similar-sized timber extending approximately 3 feet into the river at the downstream end of the bulkhead. Lower water in June 2019 also revealed that the 18-inch-wide boards noted above extended approximately 18.5 feet into the river west of the bulkhead face, and were braced in place with at least three narrower boards driven into the riverbed at a low angle below the downstream edge of the wider boards (Figures 2, 7-8).

4. The low bedrock on the west bank visible in June 2019 was approximately 5 feet west of the 18-inch-wide boards and extended over 100 feet upstream of the dam to create a channel only about 25 feet wide. The bulkhead is at the bottom of the steep east bank of sand, gravel, and cobbles, along which large rubble had been placed upstream of the bulkhead. From the downstream end of the bulkhead to the upstream side of the spillway, a row of flat stones approximately 8 inches thick was set vertically into the riverbank approximately 6 feet east of the bulkhead face, for additional bank stabilization. The top of the stones is approximately 2 feet higher than the bulkhead top, at an estimated elevation of 62 feet. The upstream end of the stone row was covered or reconstructed in concrete (Figure 2).

6. Removal of vegetation during dam removal allowed for better inspection of the sluice gate remains at intake of the outlet structure. Any remains of the 5.5-foot-square wooden gate were buried by debris/re-located spillway backfill, but gate framing and some operating mechanisms remain intact. The gate was lifted vertically on a 3-inch-diameter, over-8-foot-long screw by bevel gearing, for which the original operating mechanism does not survive. The bevel gearing was installed atop a deteriorating 4-foot-high platform of stone and concrete, which may have accommodated a small motor or a hand-powered wheel. The gate rose between brick guides, and against a steel framing attached to the brick and to a 7.5-foot-high concrete surface which includes the platform to which the bevel gearing was attached. The top of the gate was at an approximate elevation of 66.8 feet, 1.4 feet above the spillway cap (Figures 2, 9).

Although no foundation components of the spillway or spillway were exposed, the upstream spillway face with a nearly vertical upper cross section and an apparent stepped lower section appears to be an interesting variant in vernacular spillway design of overflow weirs on bedrock. As noted, construction on bedrock may not have required extensive foundation preparation for the masonry, and vertical-faced masonry used less material than stepped faces. Vertical downstream faces were common in masonry dams built on bedrock or softer river bottoms of sand, gravel, or cobbles. Bedrock made spillways less vulnerable to potential undercutting of downstream faces by falling water, or to upward pressure on the upstream face which could lead to sliding in sandy streambeds. Even on bedrock, free-standing spillways without earthen backing were not common prior to widespread availability after c.1880 of practical calculations made to assure the masonry was sufficient to withstand water at the anticipated impoundment height. Upstream masonry faces were typically sloped or stepped even without earthen backing. Backing at the Flock Process Dam spillway, built primarily in the mid-19th century, would also have been typical, but it appears that the builders reduced the amount of stepped cross section on the upstream face to take advantage of the bedrock riverbed and limit the amount of spillway masonry (Figures 2-3).

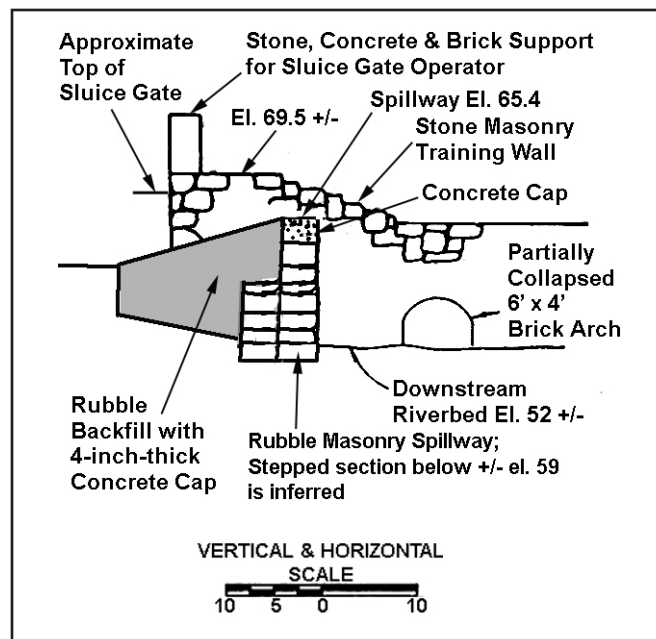
Figure 3. Schematic dam section to east at east end of dam. Base images: Roald Haestad, Inc. 1981, with elevations NAVD 1988 and details 2018 and 2019.

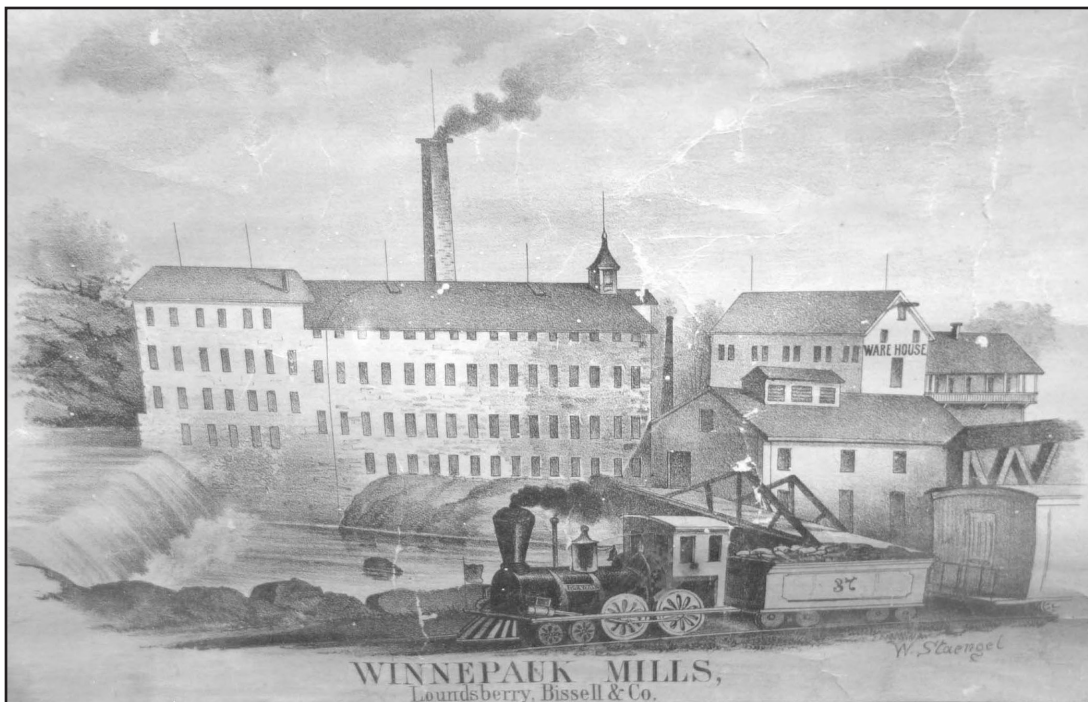
Figure 4. View east of mill complex c1858.  
Source: Stevens 1958.

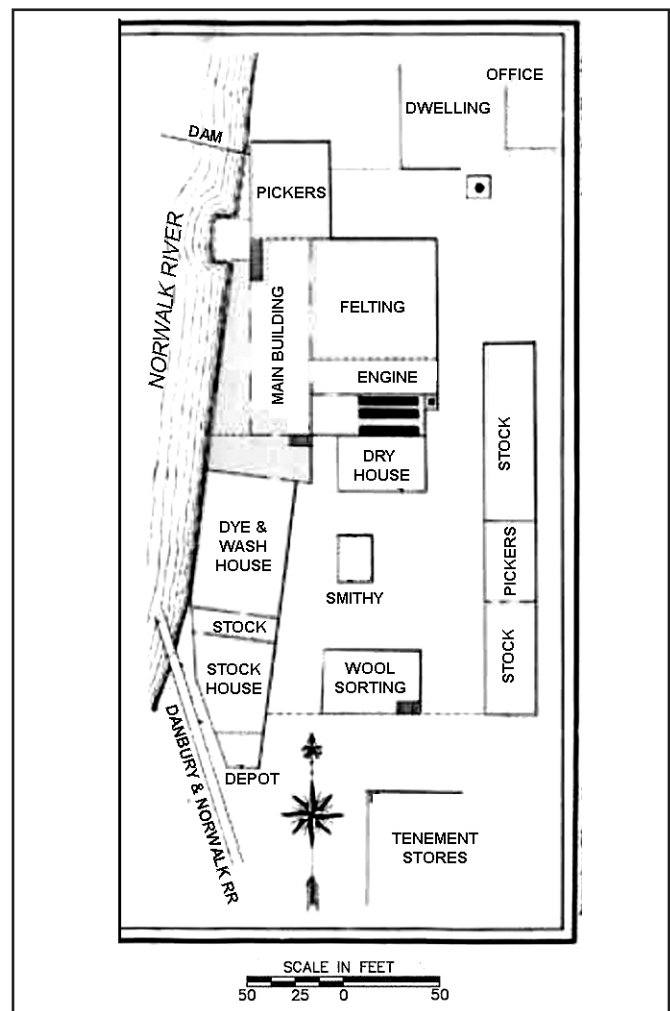
Figure 5. 1881 plan of Lounsbury & Bissell Company. *Barlow's Insurance Surveys 1881.*

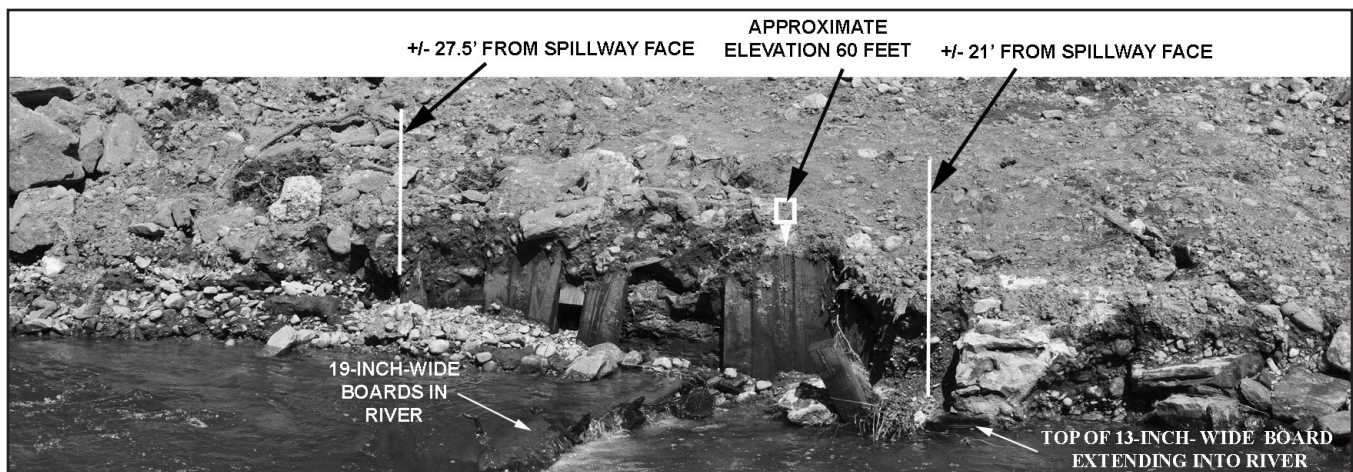
Figure 6. 2018 view east of timber bulkhead exposed after dam demolition. Source: Alexis Cherichetti.

3. Immediately upstream of the backfill, the lower river level shortly after dam removal revealed remains of a low timber bulkhead approximately 24 feet west of the former impoundment's east bank. The bulkhead visible in 2018 was 6.5-7 feet long, built primarily with 3-inch-thick, 6-to-9-inch-wide vertical boards of unknown lengths. The boards, nailed to a horizontal member not well exposed until 2019, appear to have been driven into the riverbank with board tops at approximately elevation 60 – over 5 feet lower than the pre-demolition spillway top elevation, and approximately 3 feet lower than the spillway top elevation prior to addition of the concrete cap. At the approximate longitudinal center of the bulkhead, several 18-inch-wide boards extended at least 5 feet into the river but were submerged during monitoring. A 3-inch-thick, 13-inch-wide board extends a short distance into the river at the downstream edge of the bulkhead, just

the bedrock along the west side of the narrow pre-impoundment channel has a low slope, most high water force would hit the erodible east bank and the narrow original channel bottom. The timber bulkhead and upright stone slabs noted above protected the east bank and the east side of the backfill. The concrete backfill capping installed c.1925 was probably designed to further limit backfill erosion, as were the wide boards set across most of the channel at the timber bulkhead. Backfill capping appears unusual among documented contemporary structures in Connecticut but may have been more common than known. In this case, it is possible bedrock in the riverbed inhibited installation of any timber framing to stabilize the coarse backfill (Figures 2, 6-7).

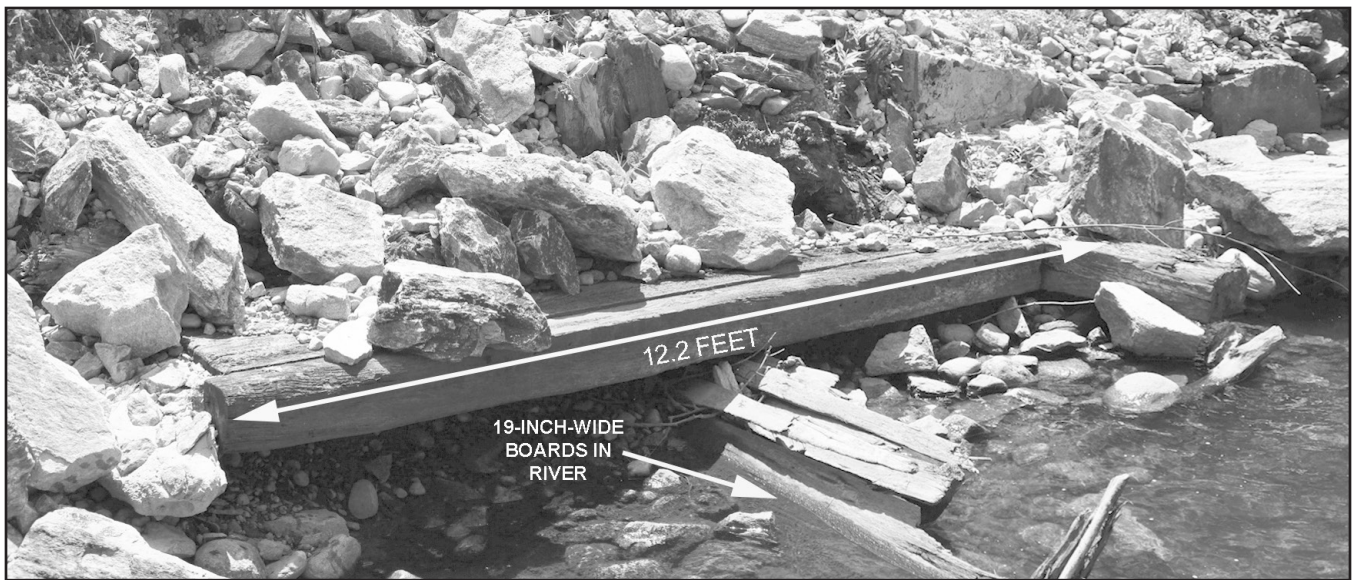
Figure 7. 2019 view southeast of timber bulkhead exposed after high water removal of vertical boards.  
Source: Alexis Cherichetti.

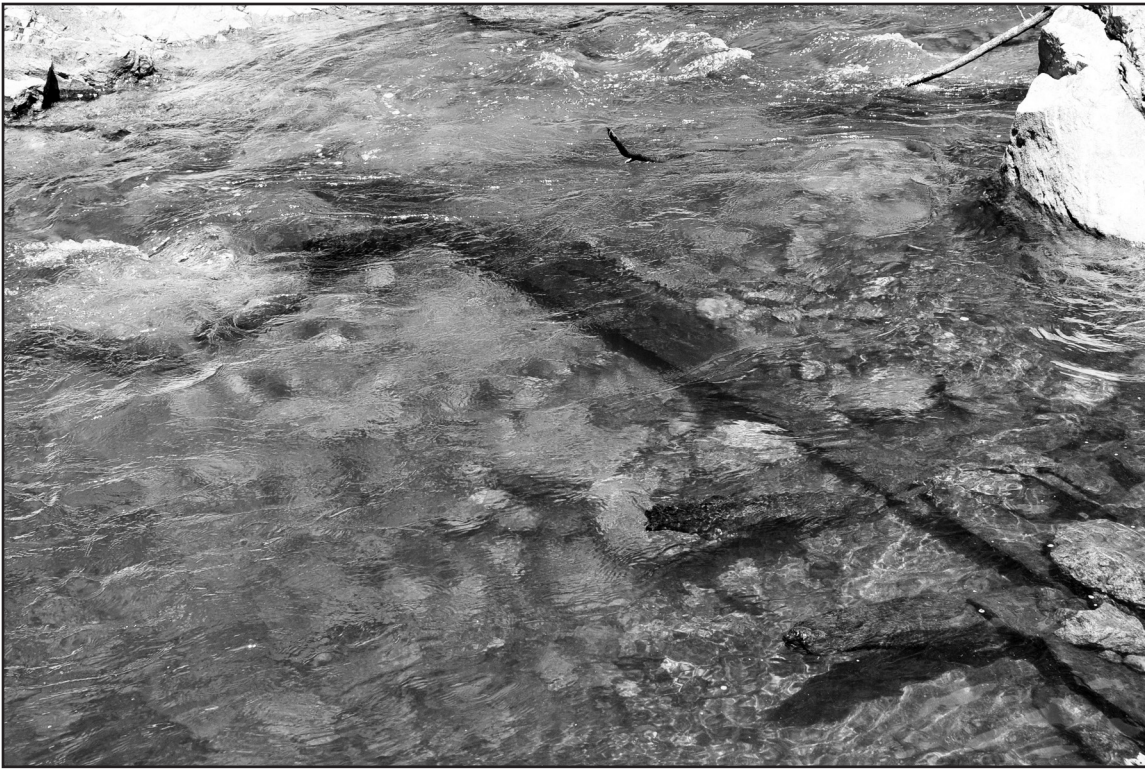
Figure 8. 2019 view northwest of 18-inch-wide boards set in riverbed with bedrock visible at upper left. Source: Alexis Cherichetti.

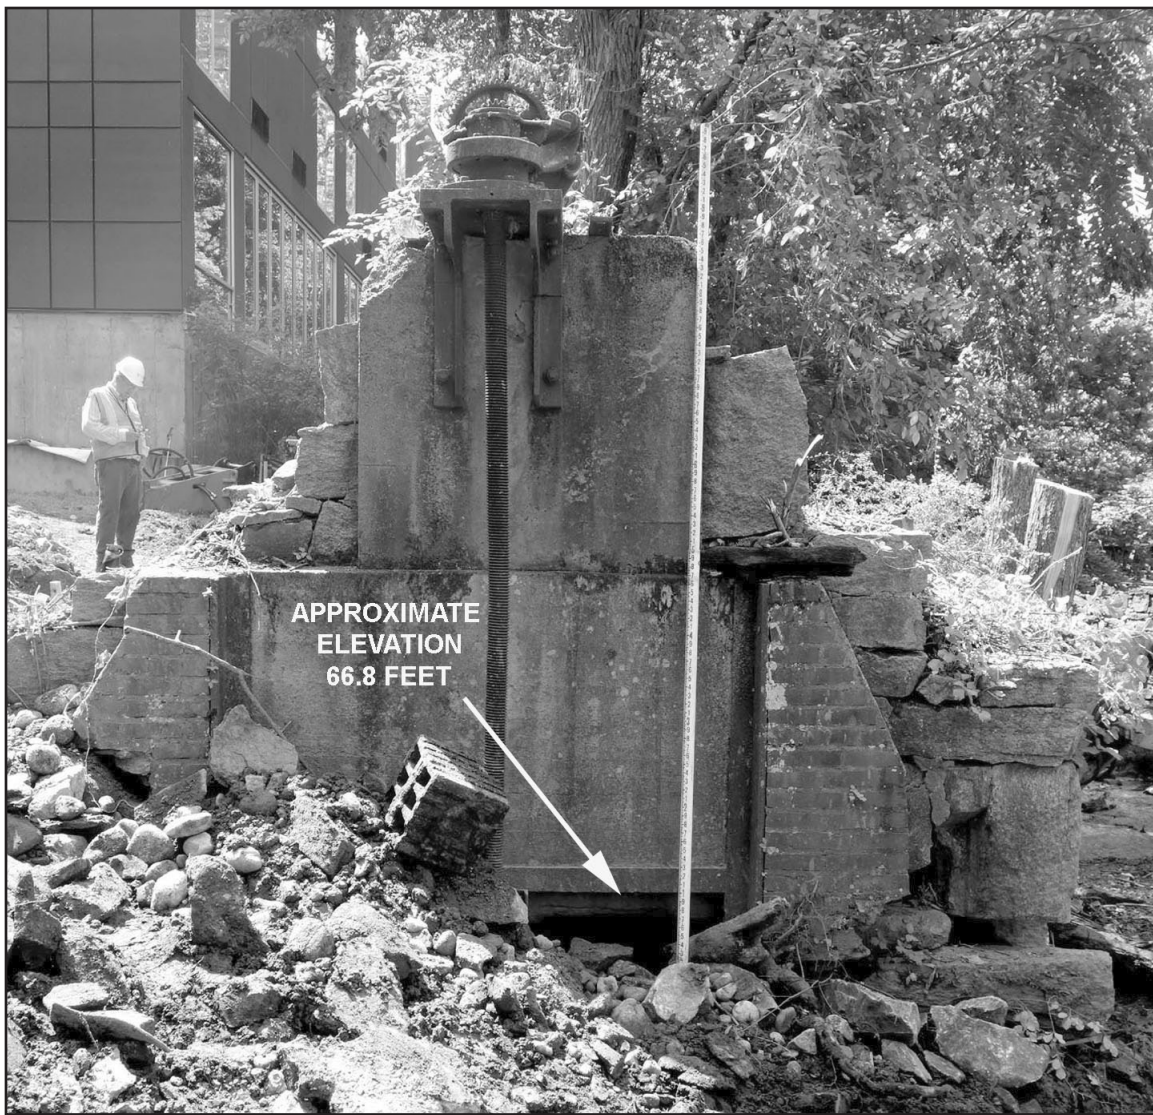
Figure 9. 2018 view south of sluice gate exposed after dam demolition.

gate. The upright stone slabs at about elevation 62 would not have obstructed flow into the gate. Assuming the gate opening was contemporary with the 1925 backfill, this site design probably required some retention at the northeast backfill corner to maintain the channel to the gate. The timber bulkhead may have been rebuilt at this time, perhaps associated with an ell-shaped east-west timber or stone configuration which has not been discovered (Figures 2, 9).
